Facility Name
123 West Main Street
Bolder, CO 65432

Inspection Start: 3/28/2020

Infrared Electrical Inspection Report

Prepared by: Wesley Kasey and Jon Hales
True Technical Services, LLC
502.939.3751
wkasey@truetechservices.com

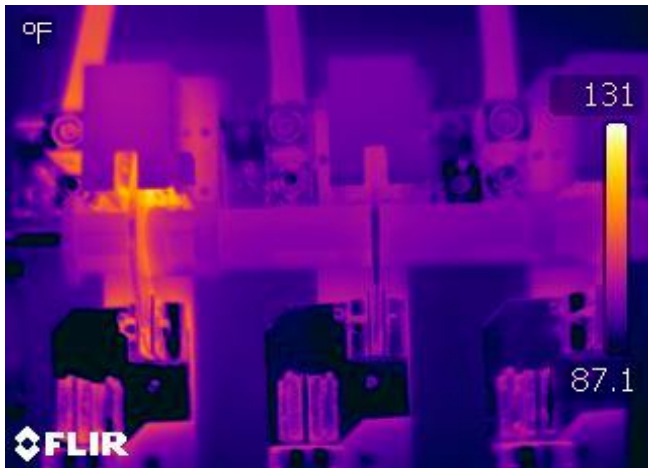
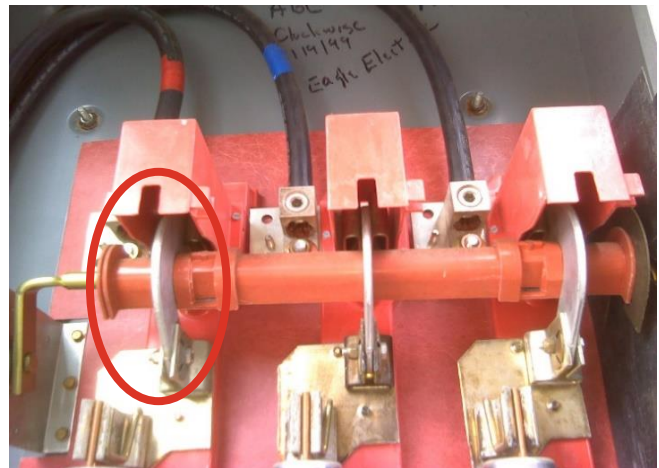
Anomaly # 1

Equipment Disconnect "Chiller 1"

Target Temperature	Reference Temperature	Temperature Difference	Criticality Rating
131°F	89°F	32°F	**

Amperage A	Amperage B	Amperage C	Rated Amps/Volts
107	109	121	480/480

Comments: Target is the phase A knife switch in Chiller 1 disconnect. Criticality raised due to device was at 20% of full load at time of inspection. Heat will rise exponentially with loading.

Recommendations: Ensure equipment is in an "Electrically Safe" condition and consult your electrical maintenance professional before performing service! Inspect, clean and tighten the knife switch components. Inspect the pivot, and entire switch component's as well. Replace parts as needed. Validate repairs with an infrared camera or spot radiometer.

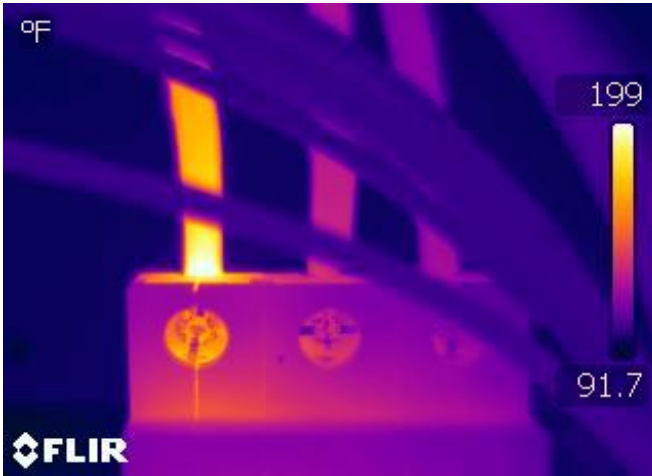
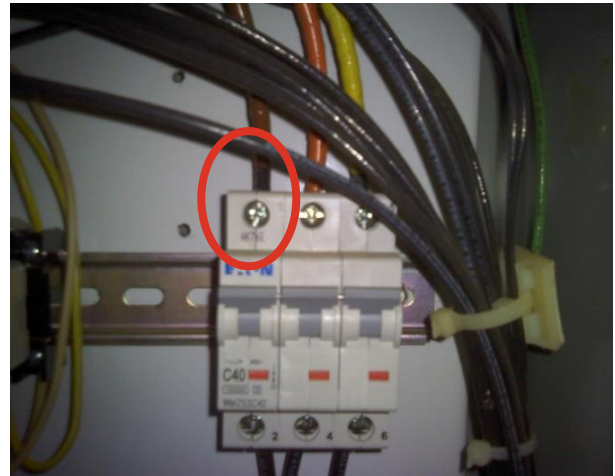
Anomaly # 2

Equipment Control Panel " New North #25"

Target Temperature	Reference Temperature	Temperature Difference	Criticality Rating
199°F	125°F	74°F	****

Comments: Target is the phase A line side wire lug on the C40 top right contactor. ***Contactor at lug appears to be damaged.

Recommendations: Ensure equipment is in an "Electrically Safe" condition and consult your electrical maintenance professional before performing service! Remove target wire. Inspect and clean wire and lug. Replace/Cut back wire as needed. Replace lug, conductor, or entire component as needed. Retighten connection to specifications. Check the entire assembly for looseness and discoloration. Validate repairs with an infrared camera or spot radiometer.

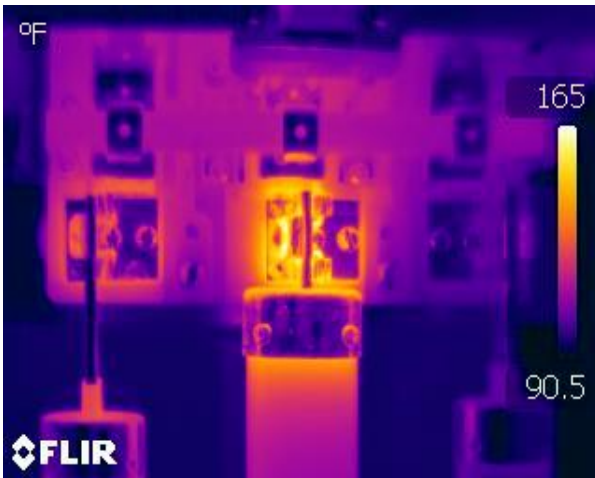
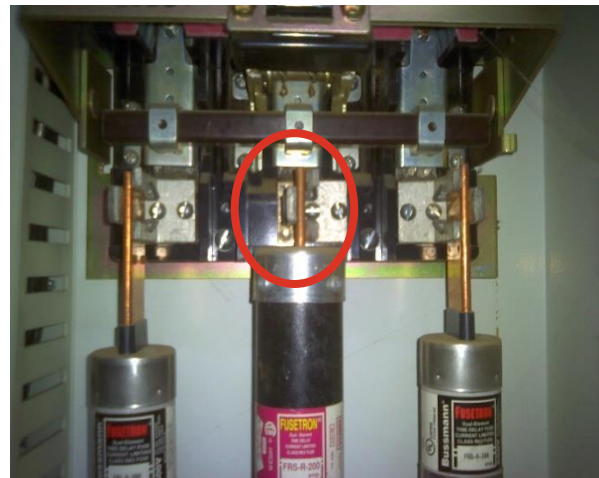
Anomaly # 3

Equipment Control Panel "Old North Dust Collector #24"

Target Temperature	Reference Temperature	Temperature Difference	Criticality Rating
165°F	103°F	62°F	***

Comments: Target is the phase B line side fuse clip. This is a repeat problem from last year and is has gotten about 50% worse.

Recommendations: Ensure equipment is in an "Electrically Safe" condition and consult your electrical maintenance professional before performing service! Fuse clip is loose, dirty, or damaged. Remove the fuse and inspect the fuse ferrell and the fuse clip. Clean and tighten the lug and all Fuse holder contact points before inserting fuse. Validate repairs with an infrared camera or spot radiometer.

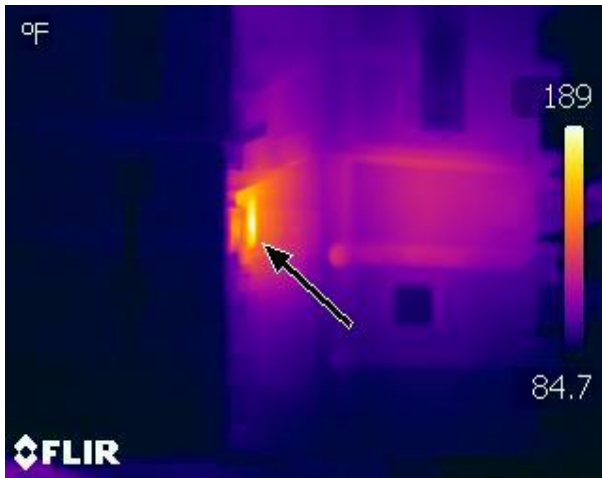
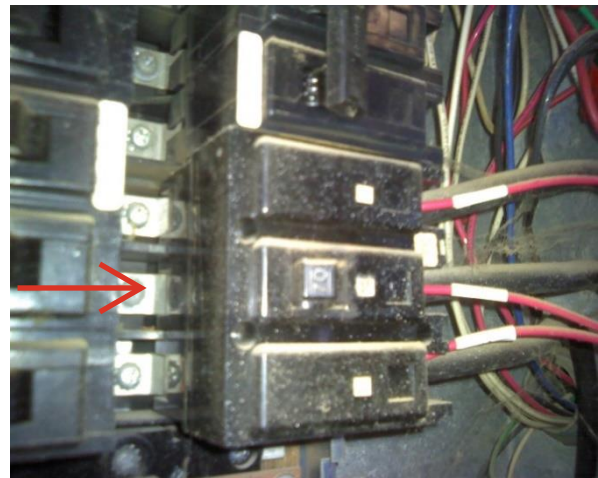
Anomaly # 4

Equipment Panel "Maintenance and Warehouse"

Target Temperature	Reference Temperature	Temperature Difference	Criticality Rating
189°F	103°F	86°F	***

Comments: Target is the phase A (Circuit 8) buss connection on the 3 pole breaker (Circuit 8,10,12) inside panel. Consider maintenance ASAP and replace breaker.

Recommendations: Ensure equipment is in an "Electrically Safe" condition and consult your electrical maintenance professional before performing service! The buss side of the breaker is loose, dirty, or damaged. Remove the breaker and inspect both breaker and lug. Clean and tighten all contact points. Validate repairs with an infrared camera or spot radiometer If hot spot persists, replace breaker.

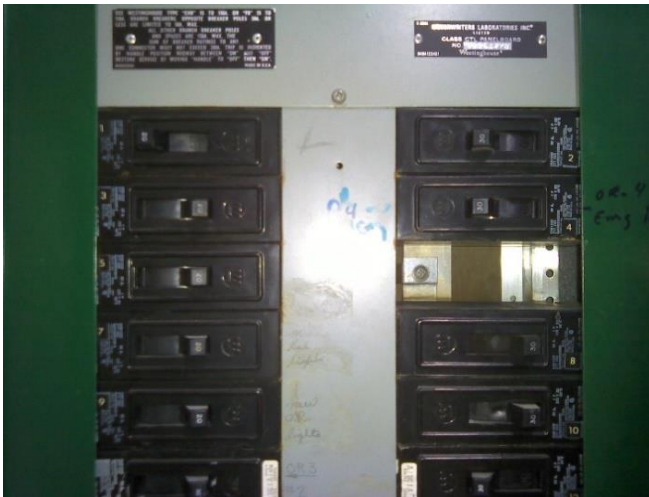
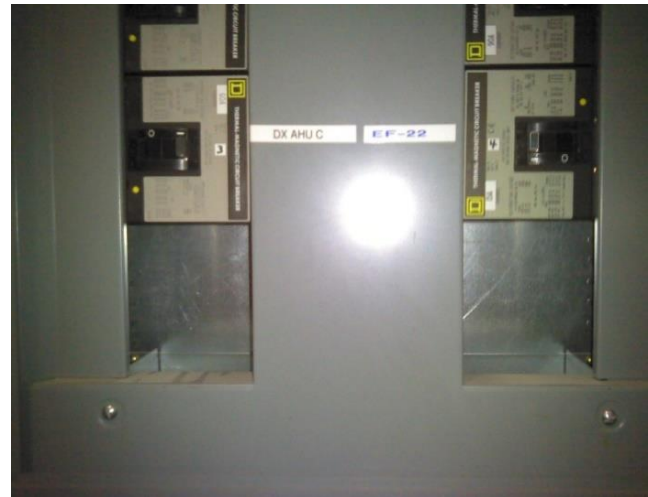
Anomaly # Visual

Comments: Panel(s) C43A pictured left and RM1G pictured right above have unused openings in the electrical enclosure, missing blanks.

Recommendations: Ensure equipment is in an "Electrically Safe" condition and consult your electrical maintenance professional before performing service! This NEC violation may be noted by inspectors and is shown for your awareness.

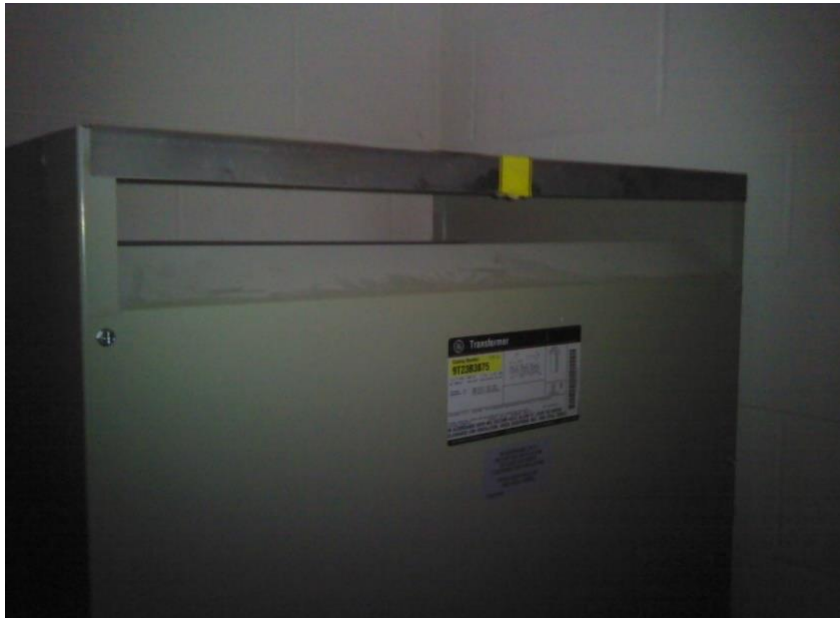
Anomaly # Visual

Comments: Target is transformer in Bay City Clinic Basement. Transformer had metal shipping brackets still attached at time of inspection. These are supposed to be removed by the installation contractor prior to energizing equipment. We opened the cover and removed the brackets.

Recommendations: Brackets removed, no further action recommended.

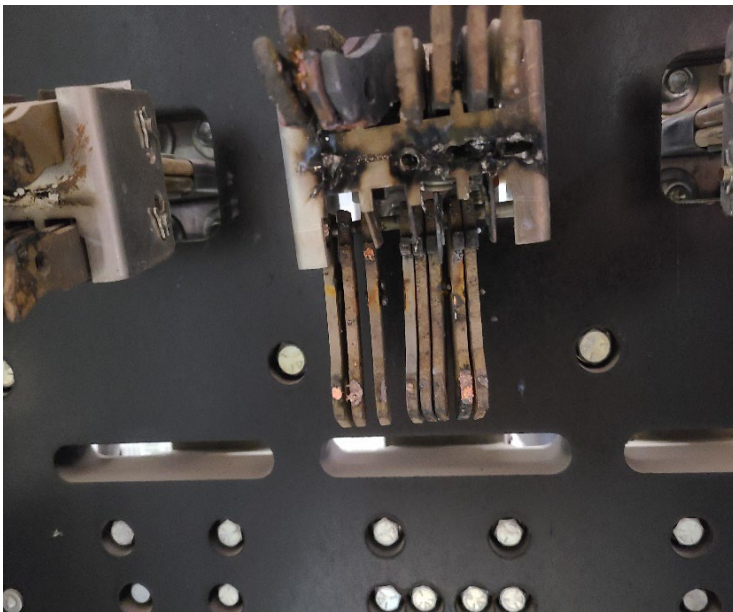
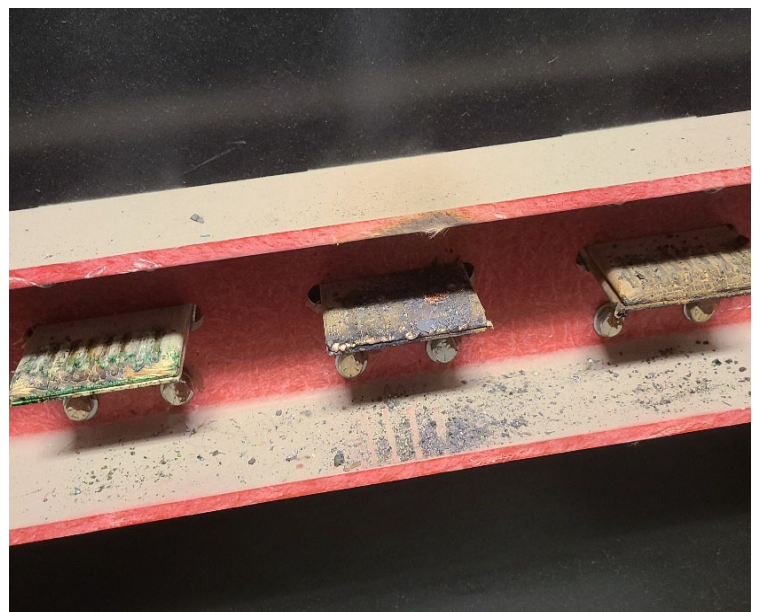
Notes/Pictures

Stab connections for phase B on the back of the bypass switch was severely damaged and fell apart upon removing the bypass switch from the ATS enclosure. Due to the location of the issue there was no thermal anomaly visible.

Have a qualified electrical contractor repair/replace the stab connections. ATS will have to be manually transitioned from normal to emergency positions until repairs are made, this will result in a brief loss of power.

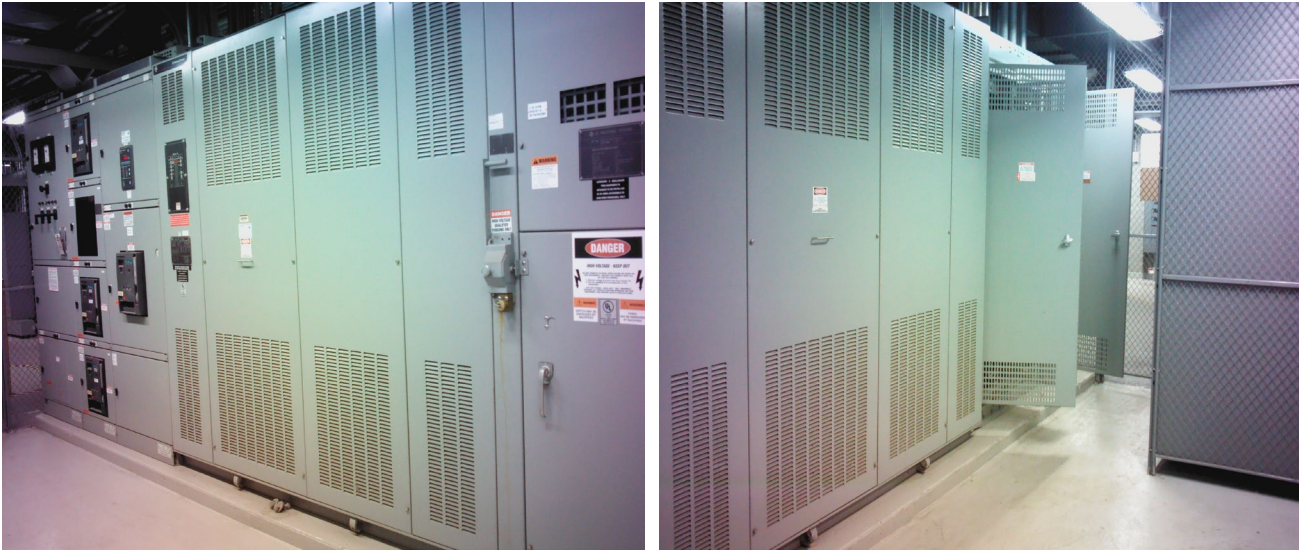
Equipment ID: _____
 Name: CP-GDP
 Location: West Clinic Bsmt. Mech Room in MR-101

Infrared	Yes
Ultrasound	Yes
Are panel(s) accessible?	Yes
Are panel(s) covers broken or missing?	No
Signs of moisture intrusion or other damage?	No
Grounding wires in place?	Yes
Any signs of overheating/arching?	No

Notes: Both infrared and ultrasound inspection were conducted on the above switchgear. (Grating and open areas of gear were used for thermal inspection). Ultrasound was used throughout the gear to inspect for arcing, tracking and corona. No anomalies found at time of inspection. Continue annual infrared and ultrasound inspection on gear.

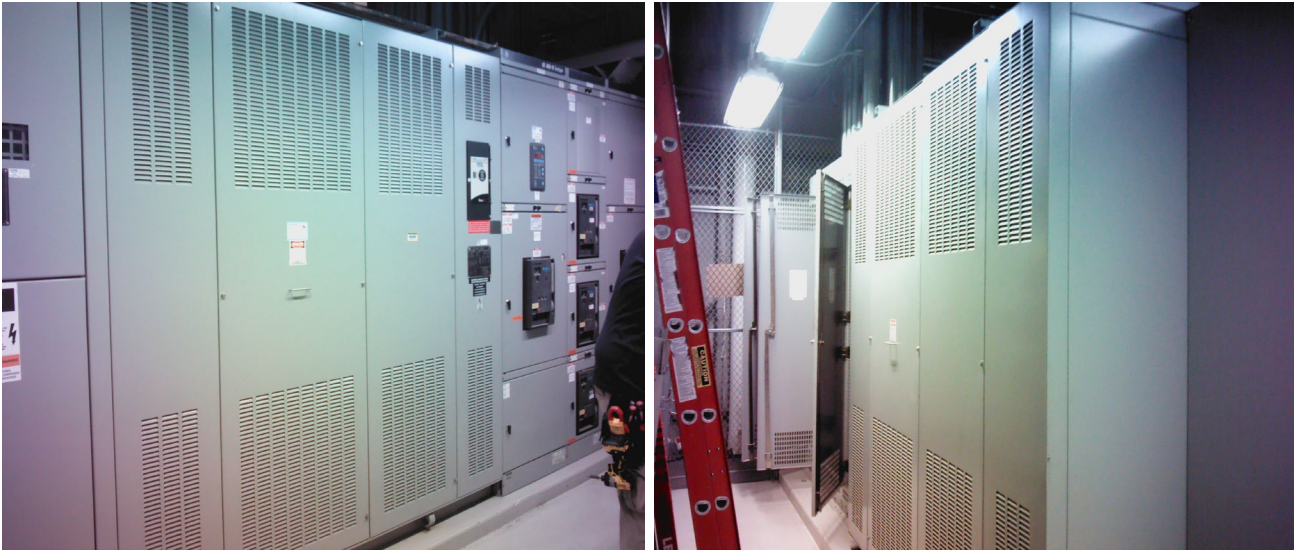
Equipment ID: _____
 Name: IJ-GDP
 Location: West Clinic Bsmt. Mech Room in MR-101

Infrared	Yes
Ultrasound	Yes
Are panel(s) accessible?	Yes
Are panel(s) covers broken or missing?	No
Signs of moisture intrusion or other damage?	No
Grounding wires in place?	Yes
Any signs of overheating/arching?	No

Notes: Both infrared and ultrasound inspection were conducted on the above switchgear. (Grating and open areas of gear were used for thermal inspection). Ultrasound was used throughout the gear to inspect for arching, tracking and corona. No anomalies found at time of inspection. Continue annual infrared and ultrasound inspection on gear.
